Manhole Inspection Summary

Manhole # S21AA_019MH

Insp Date: **9/11/07 8:18 AM**

Location Address: **1621 MOSHER ST**

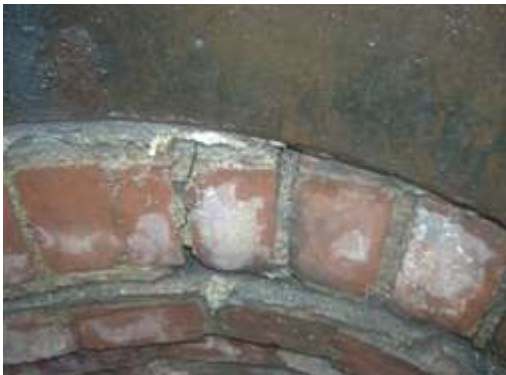
Defect 2

Condition: ☐ Sound ☐ Cracked ☐ Root Intrusion ☐ Loose Brick ☒ **Deteriorated**

DETERIORATED CHIMNEY

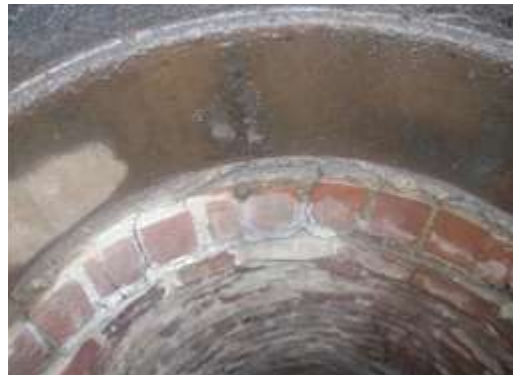
Defect 3

Offset: **1** (in.)

FRAME OFFSET

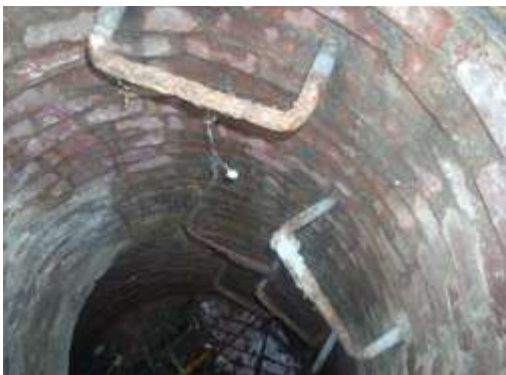
Defect 1

Count: **6** Missing: **0** ☒ **Corroded**

CORRODED STEPS

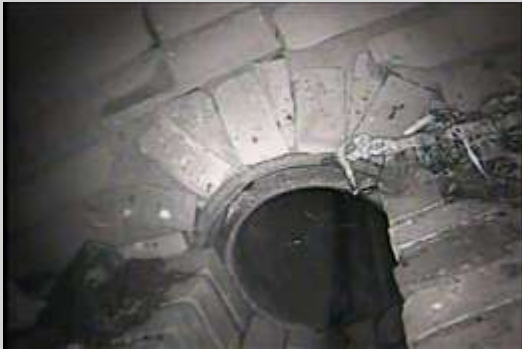
12 O'Clock Outflow

8 in. Circular Gravity Sewer
Pipe Out @ 12 O'Clock

Pipe Height: **7.2** (in.) Rod and Bar (Angled)
Pipe Material: **Clay** ☐ Pipe Lined
Invert Depth: **9.65** (ft.) Flow Characteristics: **None**
Deposits: ☒ None ☐ Mud ☐ Sludge ☐ Debris ☐ Grease
Silt Depth: (in.) Deposits Extent:
Infiltration: **None** Pipe Seal Cond: **Sound**

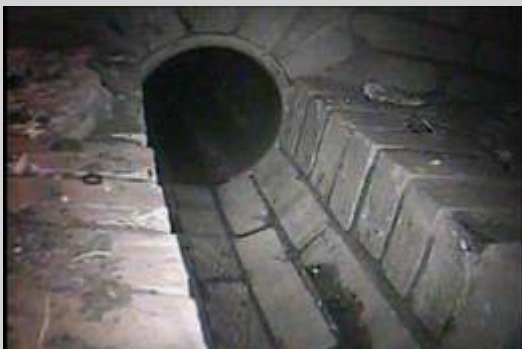
6 O'Clock Inflow

8 in. Circular Gravity Sewer
Pipe In @ 6 O'Clock

Pipe Height: **7.2** (in.) Rod and Bar (Angled)
Pipe Material: **Clay** ☐ Pipe Lined
Invert Depth: **9.44** (ft.) Flow Characteristics: **None**
Deposits: ☒ None ☐ Mud ☐ Sludge ☐ Debris ☐ Grease
Silt Depth: (in.) Deposits Extent:
Infiltration: **None** Pipe Seal Cond: **Sound**

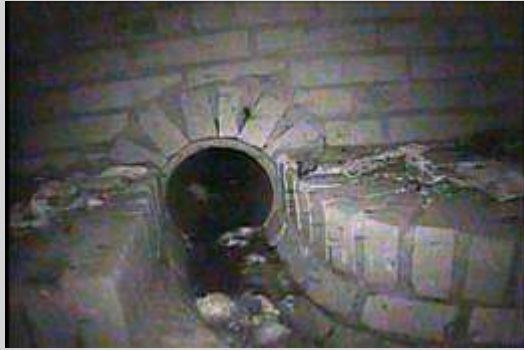
9 O'Clock Inflow

8 in. Circular Gravity Sewer

Pipe In @ 9 O'Clock

Invert Depth: **9.20** (ft.) Flow Characteristics: **Slow**

Infiltration: **None** Pipe Seal Cond: **Sound**
